SURVEY REPORT NO: 19-0245-C

NATURE OF SURVEY: Scope of Demolition

NAME OF DOCK: Piety Street Wharf Firewall / Truss Wall

PLACE OF SURVEY: Piety Street Wharf, New Orleans, LA

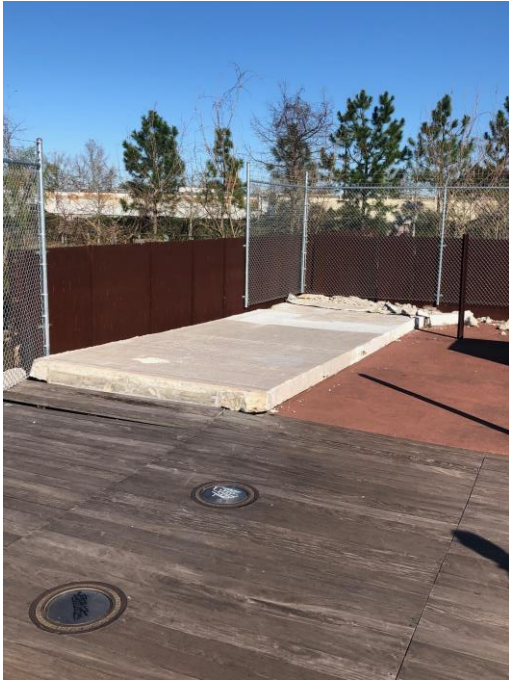
Picture 1

- Fire / truss north wall collapsed on dock deck and is blocking north swing gate access
- Fire / truss east wall 12'0" in height x 0'8" wide x 50'0" in length collapsed and penetrated through the dock below on river side
- Fire / truss west wall totally collapsed and lying in river
- Concrete privacy wall, river side 8'0", heavily damaged / collapsing
- Dock deck damaged in scattered, random locations in way of concrete falling atop from wall collapsing (see photographs)

- Immediate demolition of Piety Street Wharf damage for safety concerns.
- Remove north fire / truss wall collapsed and lying on dock/deck blocking north swing gate access (Picture #1).
- Remove fire / truss east wall 12'0" in height, 8" wide, 50'0" in length collapsed on river side and penetrated through the dock / deck below (Pictures #2 / #2A).
