SURVEY REPORT NO: 19-0245-D

NATURE OF SURVEY: Completion of Scope of Demolition

NAME OF DOCK: Piety Street Wharf Firewall / Truss Wall

PLACE OF SURVEY: Piety Street Wharf, New Orleans, LA

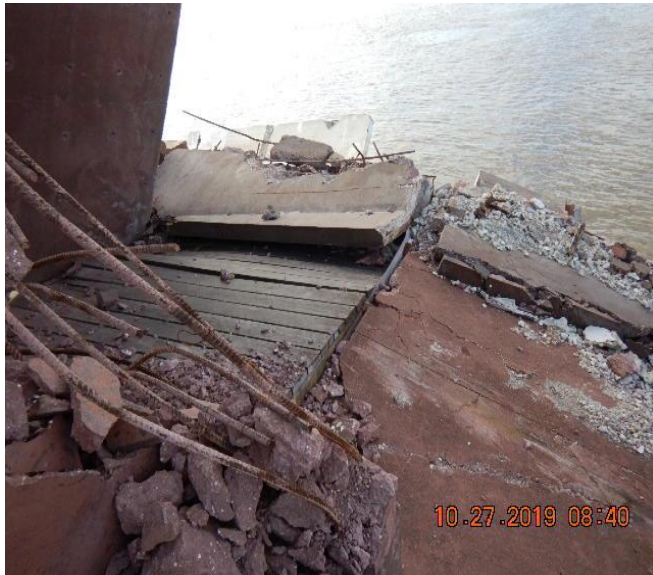
Picture 1 – Before Demolition

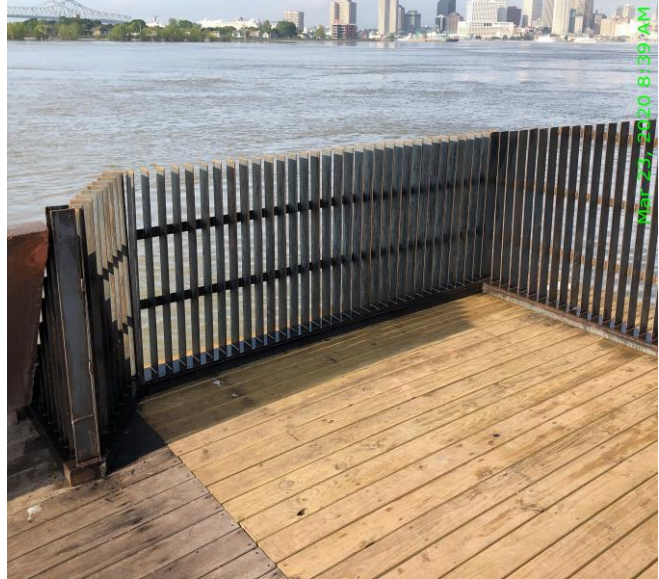
Upon inspection of Piety Street Wharf, demolition was noted to be completed with area cleaned. Steel safety rails were fabricated and installed. LED lighting was installed. Piety Street Wharf appears to be suitable and safe for its intended purpose.

Picture 2 – After Demolition and Clean-up

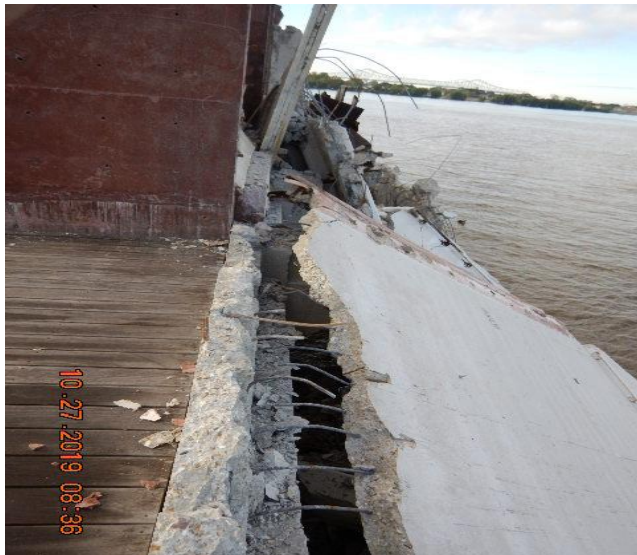
Picture 3 – Before Demolition

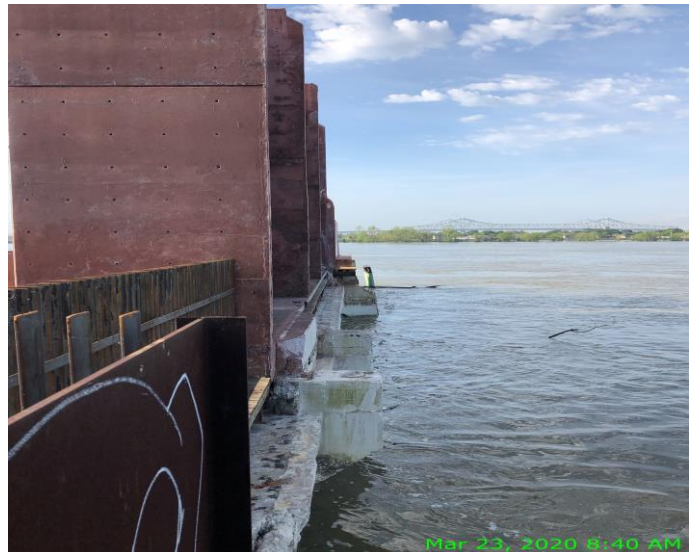
Picture 4 – After Demolition and Clean-up

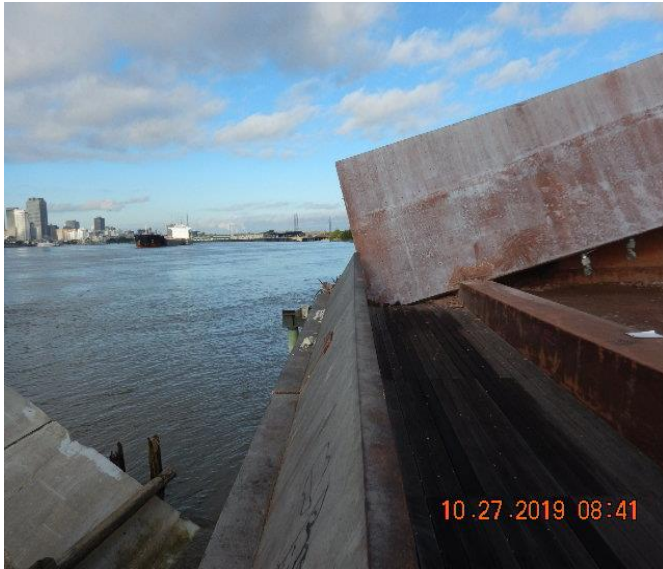
Picture 5 – Before Demolition

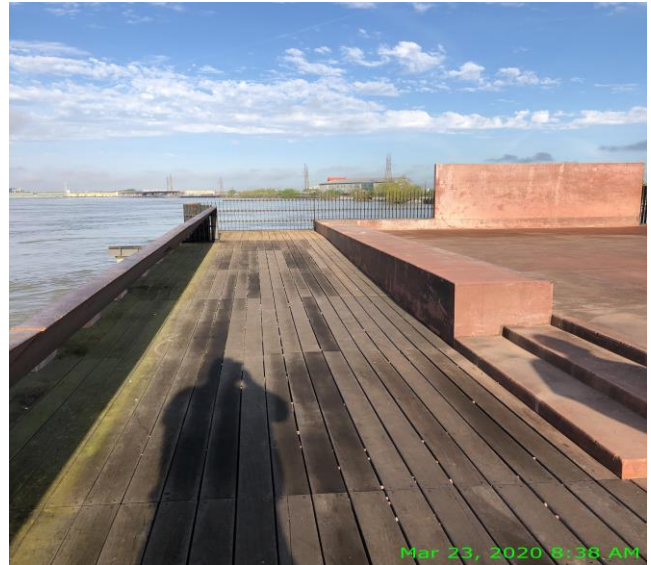
Picture 6 – After Demolition and Clean-up

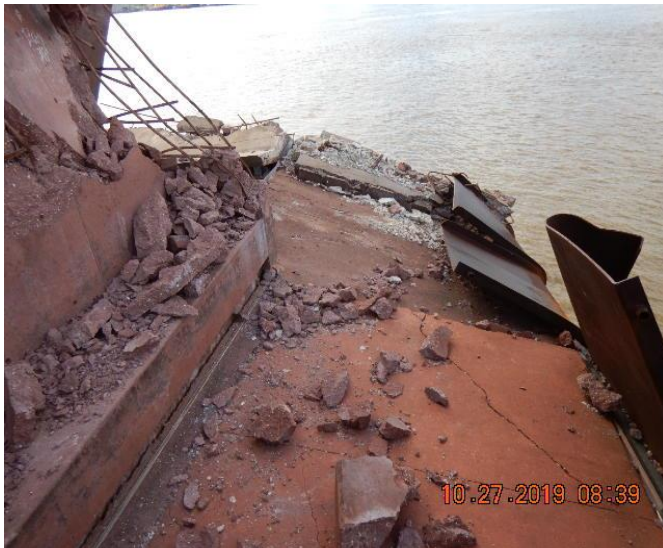
Picture 7 – Before Demolition

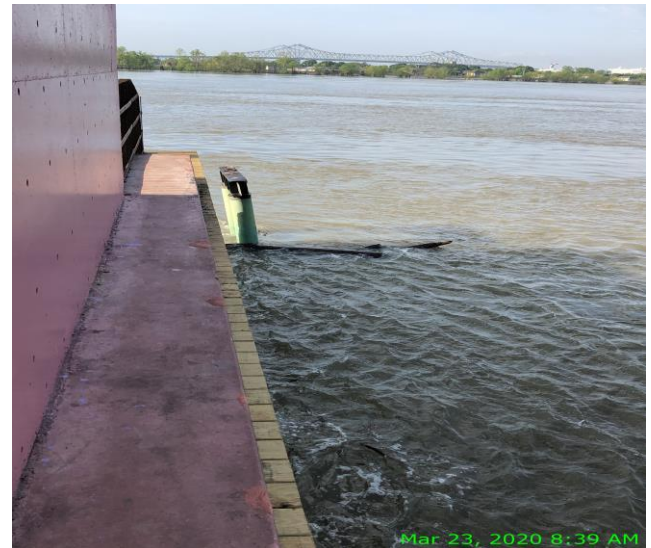
Picture 8 – After Demolition and Clean-up

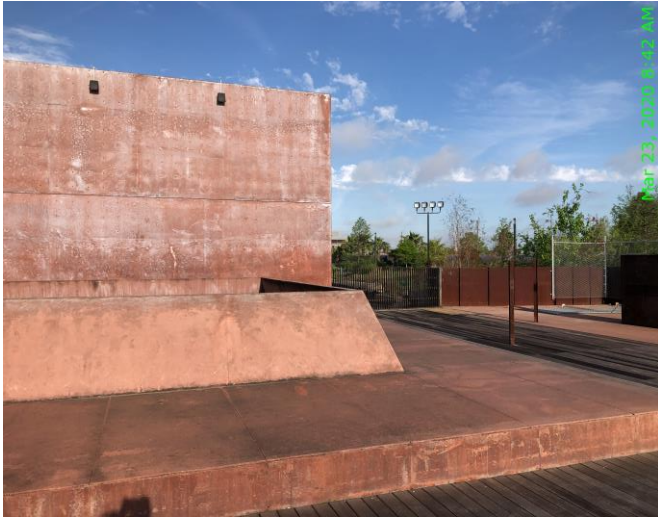
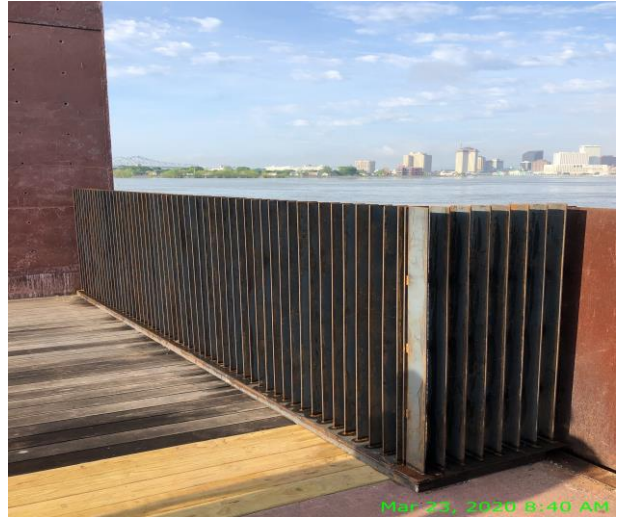
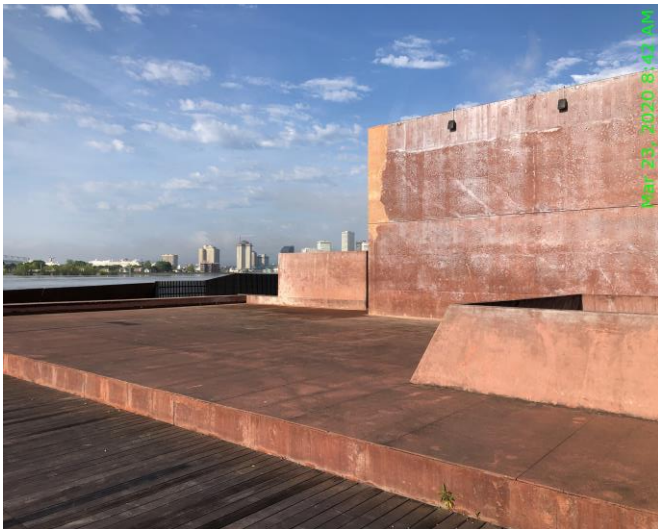
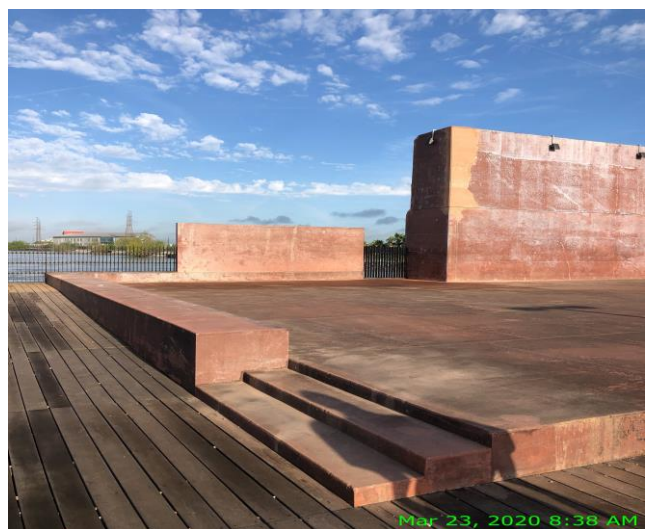
Pictures 9-12: Additional Miscellaneous Pictures / After Demolition and Clean-up
