June 20, 2019

RE: Allision Damage to Piety Street Wharf
June 6, 2019
USF Job Number 19.01.150

As you are aware, we performed an inspection at the Piety Street Wharf structure in New Orleans, Louisiana on June 11, 2019. This correspondence is offered as a summary of our findings in connection with that inspection.

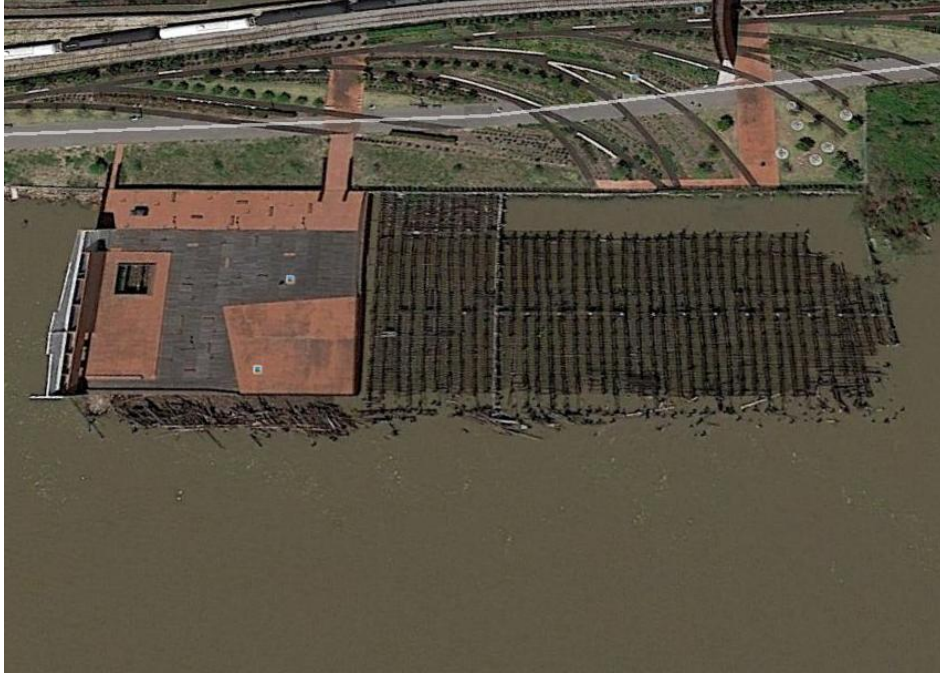
Photograph 1

Aerial view of the Piety Street Wharf reportedly taken in April of 2016.

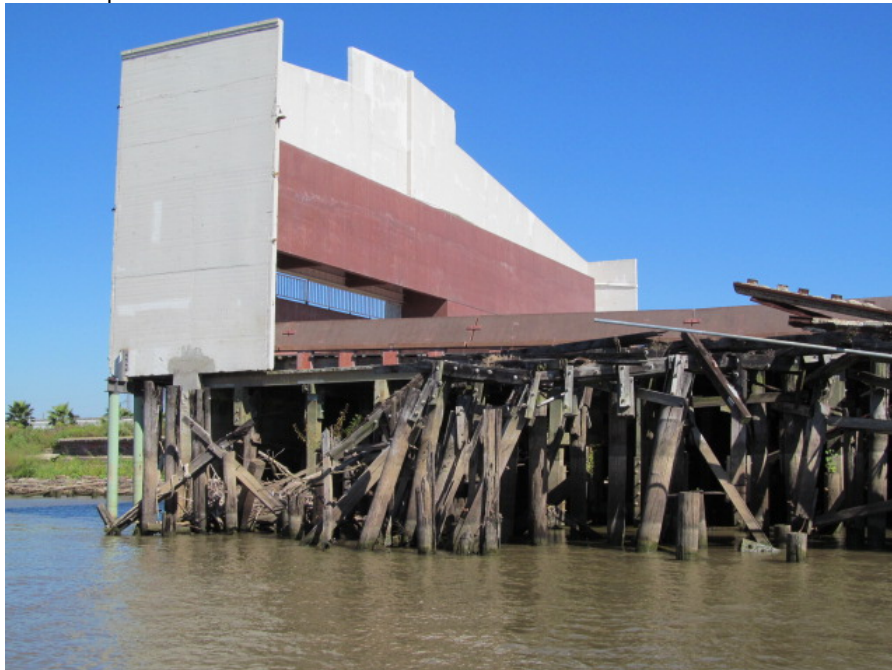
Photograph 2

View of the upriver portion of the Piety Street Wharf taken from the river in September of 2016.

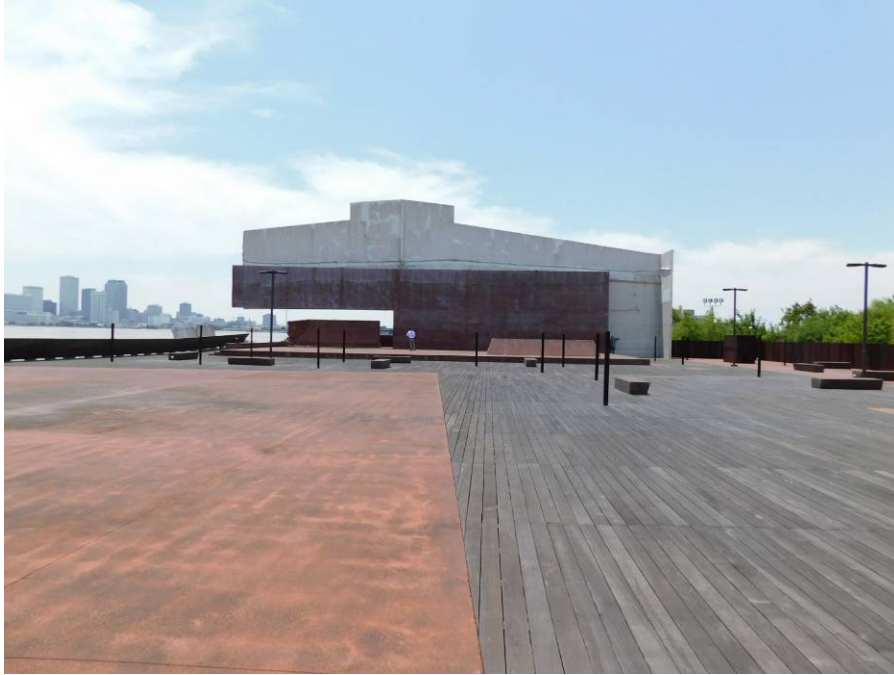
Photograph 3

View of the Piety Street Wharf facing upriver.

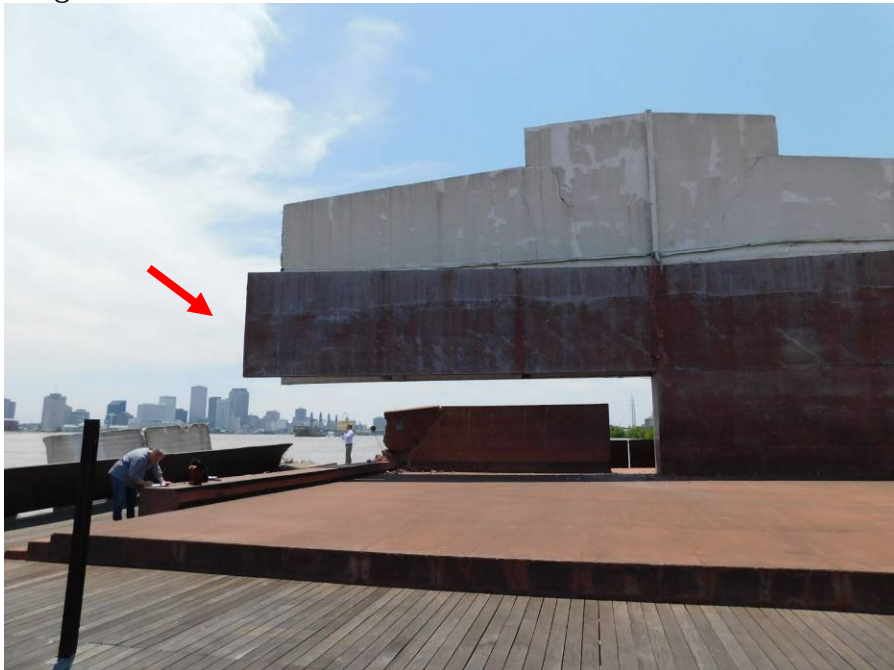
Photograph 4

- The concrete endwall at the channelside end of the firewall at the upriver end of the wharf was disconnected from the structure and displaced downwards into the river. The displaced endwall was oriented upright and the upper end of the wall extended approximately 10 feet above the river surface.

View of the upriver end of the Piety Street Wharf. Note the end wall missing from the channelside end of the firewall.

In order to repair the damage to the Piety Street Wharf caused by the reported allision of June 6, 2019, we recommend that the displaced concrete endwall, approximately 1,000 square feet, the damaged portion of the concrete firewall, approximately 70 linear feet, the damaged portion of the concrete truss wall, approximately 50 linear feet, the damaged 2-pile support bent beneath the upriver corner of the wharf, the damaged deck overhang and handrails at the upriver end of the wharf, approximately 250 square feet, the damaged wood deck framing at the upriver corner of the wharf, approximately 60 square feet, the damaged portion of the decorative concrete wall at the deck level, approximately 15 linear feet, and the damaged upriver portion of the angled concrete handrail along the edge of the upriver end of the wharf, approximately 25 linear feet, be removed and replaced with similar materials. All repairs shall be performed by qualified contractors with appropriate marine insurance coverage and in accordance with all applicable state and local building codes and standards.

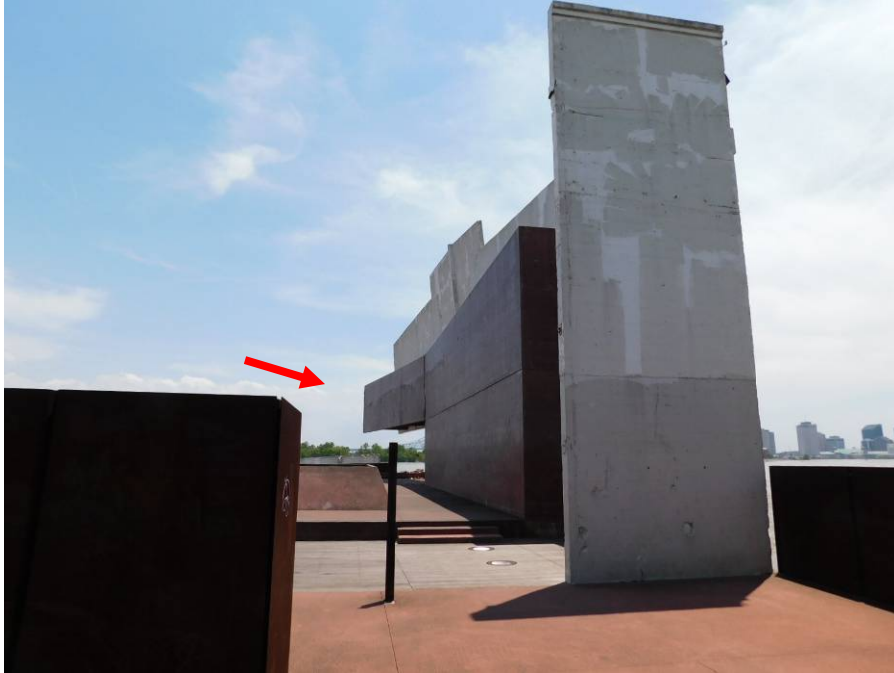
Photograph 5

- The channelside ends of the concrete firewall and the adjacent concrete truss wall section at the upriver end of the wharf were unsupported due to the displaced endwall and were displaced somewhat downwards and downriver. Separations were present between the interior concrete brace walls that joined the concrete firewall and concrete truss wall sections.

View of the upriver end of the Piety Street Wharf facing towards the river channel. Note that the end of the truss wall is displaced in the downriver direction.

Due to the current potentially unstable condition of the firewall and truss wall at the upriver end of the wharf caused by the displacement of the concrete endwall at the upriver corner of the structure, we recommend that a temporary support be installed beneath the unsupported channelside ends of the concrete firewall and truss wall to stabilize the walls and minimize additional movement or damage until appropriate repairs can be effected to the wharf.

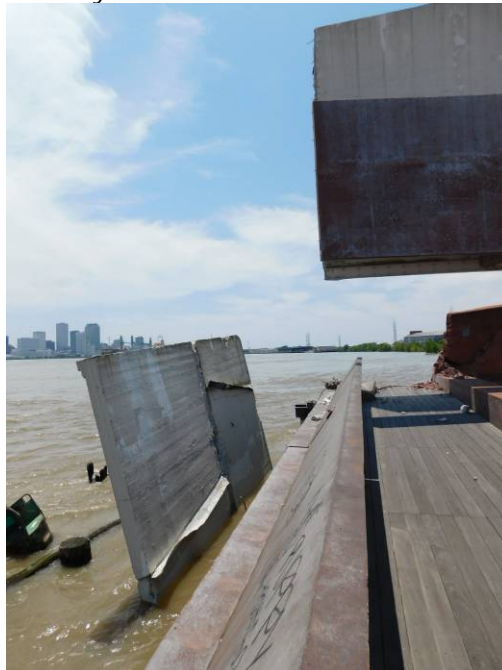
Photograph 6

View of the displaced concrete end wall of the firewall at the upriver end of the Piety Street Wharf.

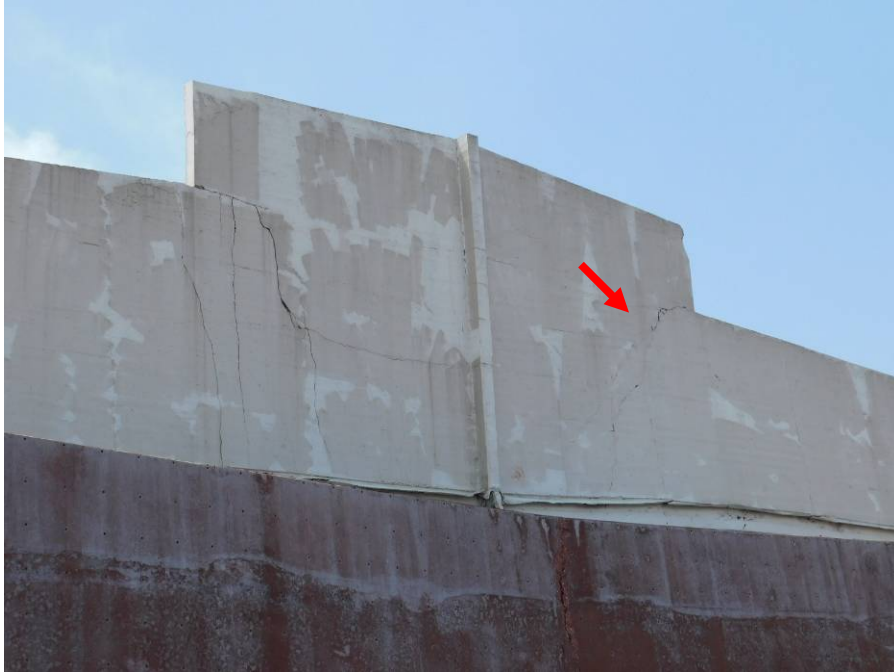
Photograph 7

- Cracks that extended from the deck level to the top surface of the firewall were present in the central portion of the concrete firewall.
- Cracks were present in the central portion of the concrete truss wall directly above the landside end of the open span of the wall.

View of cracks in the upper portion of the concrete firewall at the upriver end of the Piety Street Wharf.

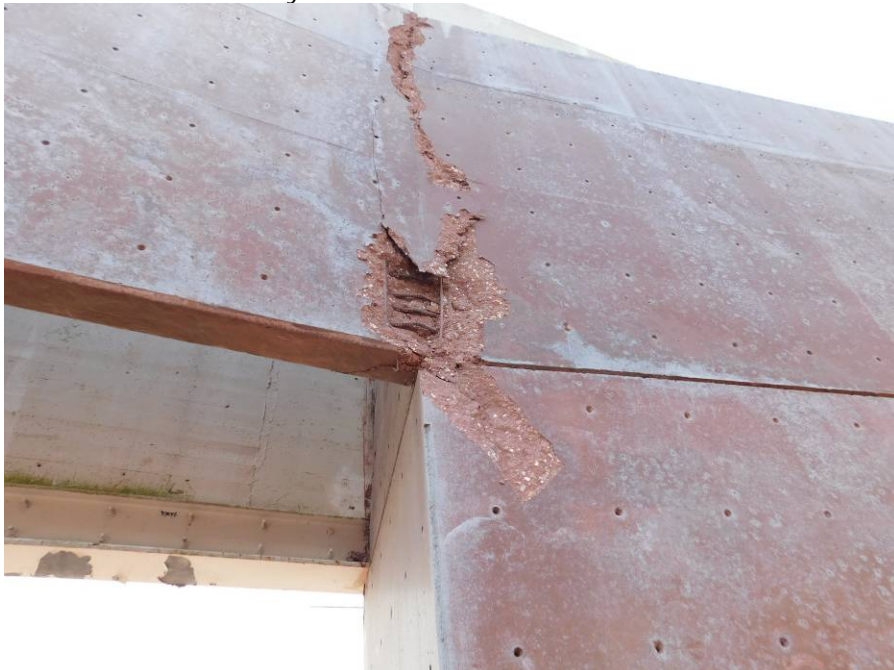
Photograph 8

View of cracks in the lower portion of the concrete truss wall at the upriver end of the Piety Street Wharf.

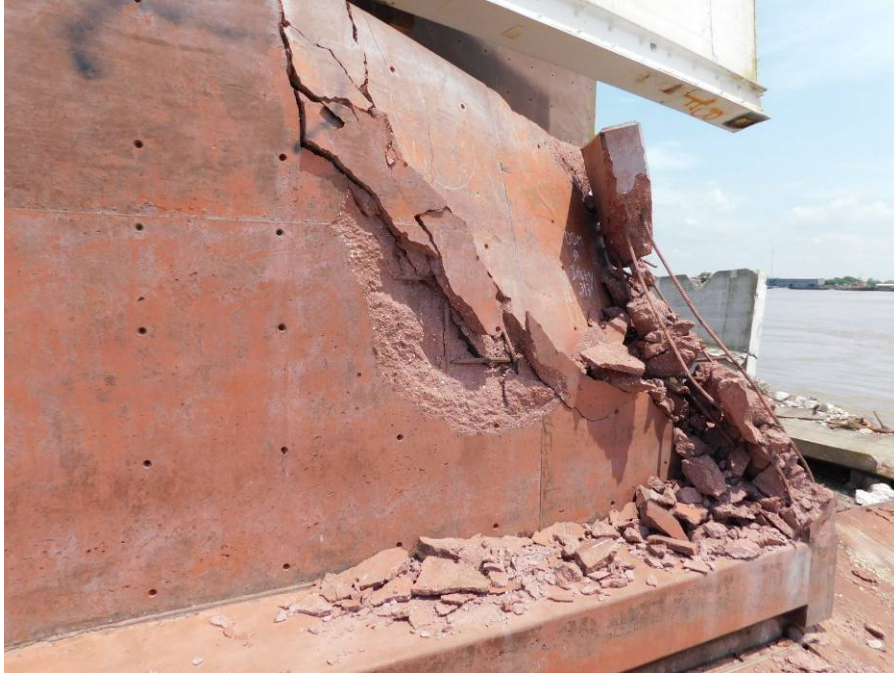
Photograph 9

- Some of the wood deck framing at the upriver channelside corner of the wharf was cracked and displaced.
- Approximately 15 feet of the channelside end of the decorative concrete wall on the deck level at the upriver end of the wharf was cracked and displaced.

View of damage to the channelside end of the decorative concrete wall on the deck level at the upriver end of the Piety Street Wharf.

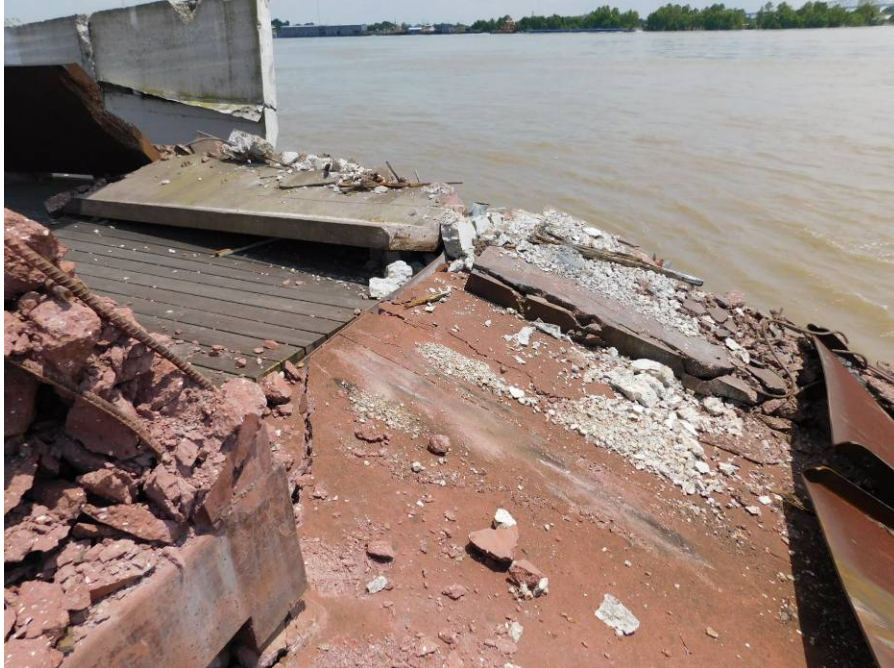
Photograph 10

View of cracked and displaced concrete deck paving and wood decking at the upriver channelside corner of the Piety Street Wharf.

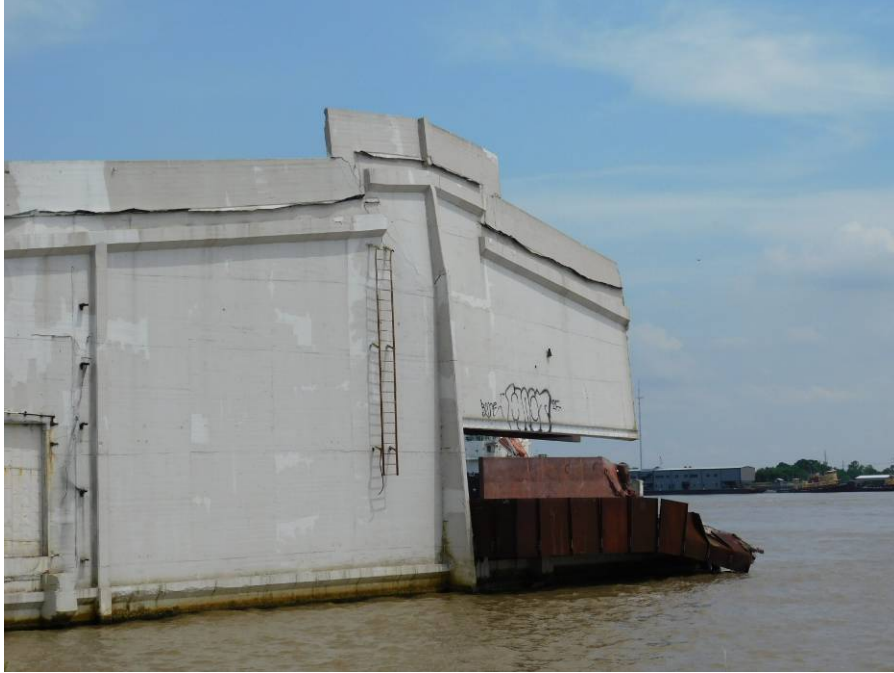
Photograph 11

View of the upriver end of the Piety Street Wharf facing downriver.

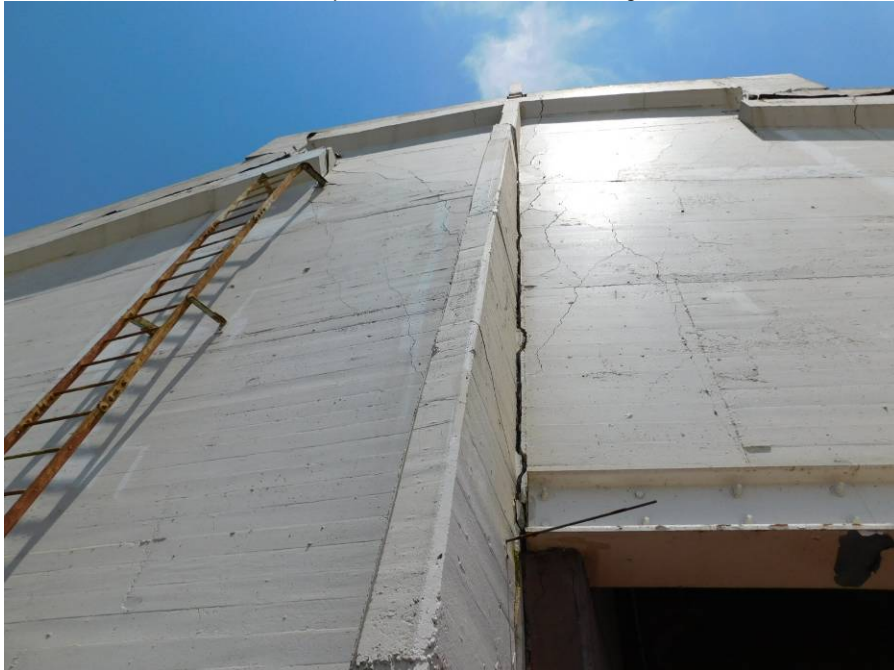
Photograph 12

View of cracks and displacement of the central portion of the concrete firewall at the upriver end of the Piety Street Wharf.

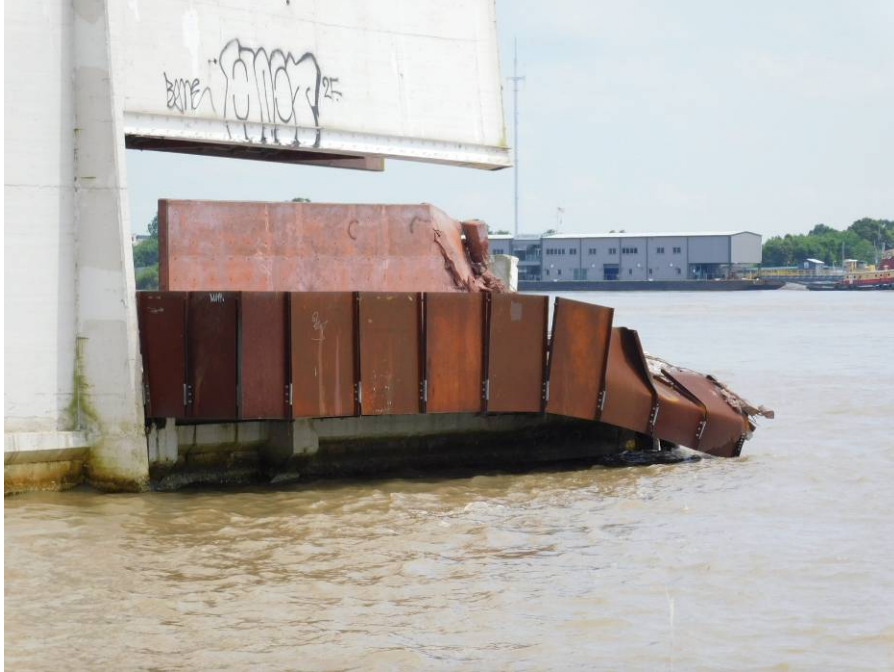
Photograph 13

- The channelside end of the deck overhang at the upriver end of the wharf was cracked and displaced downwards and several of the steel handrail panels were bent and displaced. Cracks were present in the concrete deck paving of the overhang that extended to within approximately 15 feet of the landside edge of the overhang area. The 2-pile steel support bent directly beneath the upriver channelside corner of the wharf overhang that extended from the deck level to the top surface of the firewall was displaced and bent.

View of damage to the concrete deck overhang and steel handrail panels at the upriver end of the Piety Street Wharf.

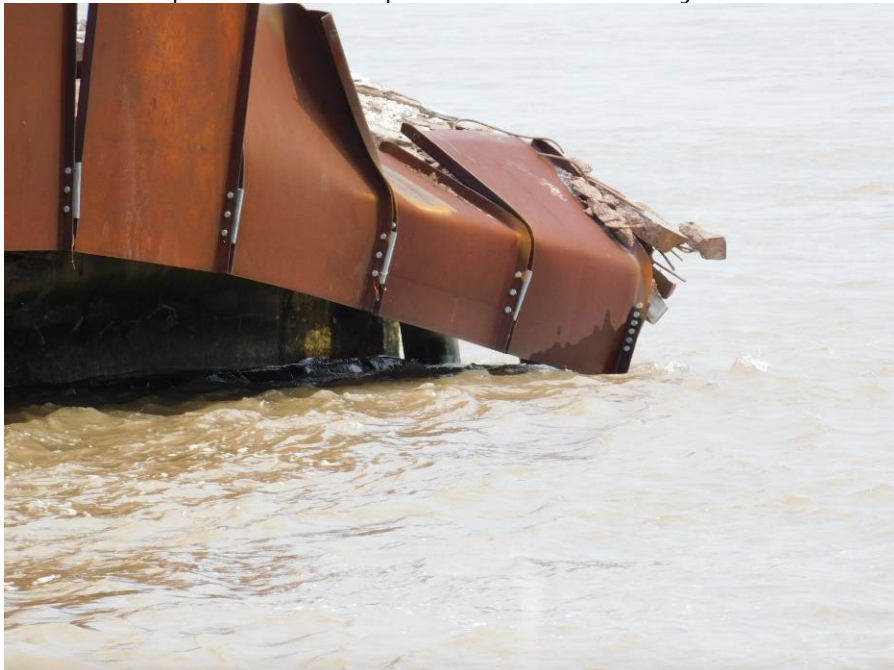
Photograph 14

Close-up view of damage to the concrete deck overhang and steel handrail panels at the upriver end of the Piety Street Wharf.
